Docket No. 217 – Development and Management Plan Inspection

Northeast Utilities Service Company Certificate of Environmental Compatibility and Public Need for the construction of a 345-kV electric transmission line and reconstruction of an existing 115-kV electric transmission line between Connecticut Light and Power Company's Plumtree Substation in Bethel, through the towns of Redding, Weston, and Wilton, and to the Norwalk Substation in Norwalk, Connecticut.

Date: December 30, 2005

Location: Norwalk Substation Expansion

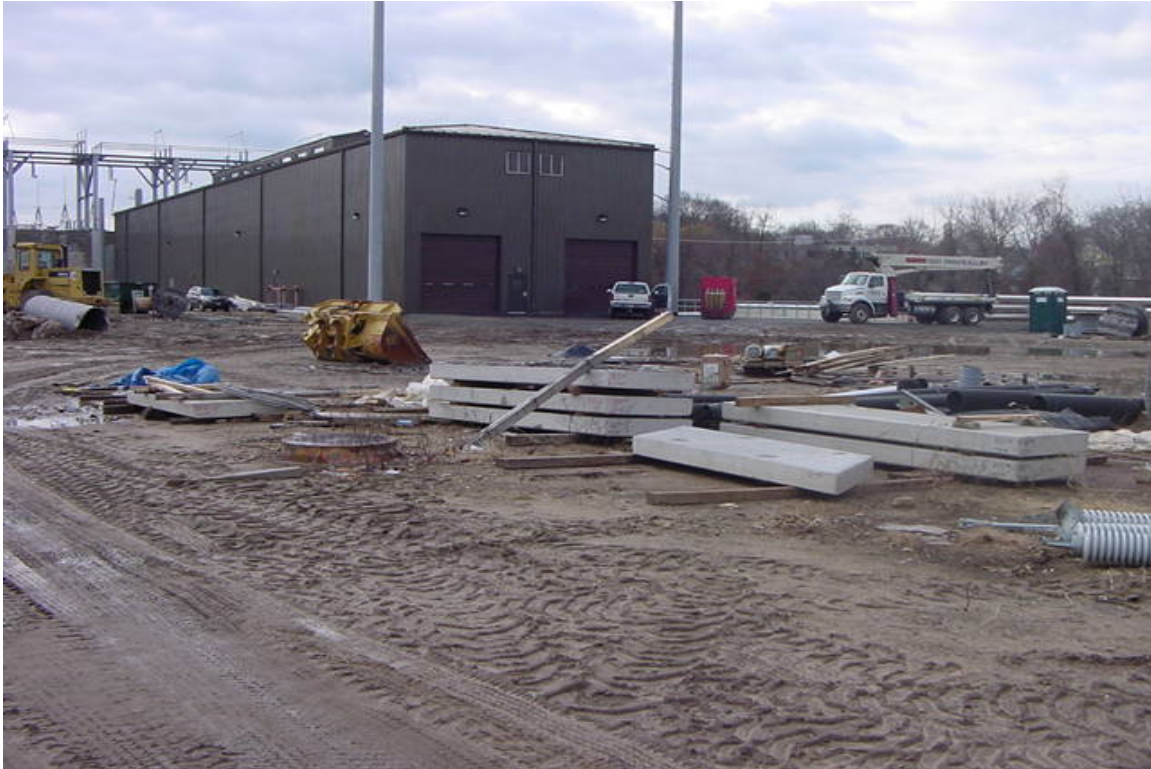
Norwalk Substation: Overview of the yard looking towards the GIS building. The site was somewhat muddy due to rain and thaw periods. 12/30/05.

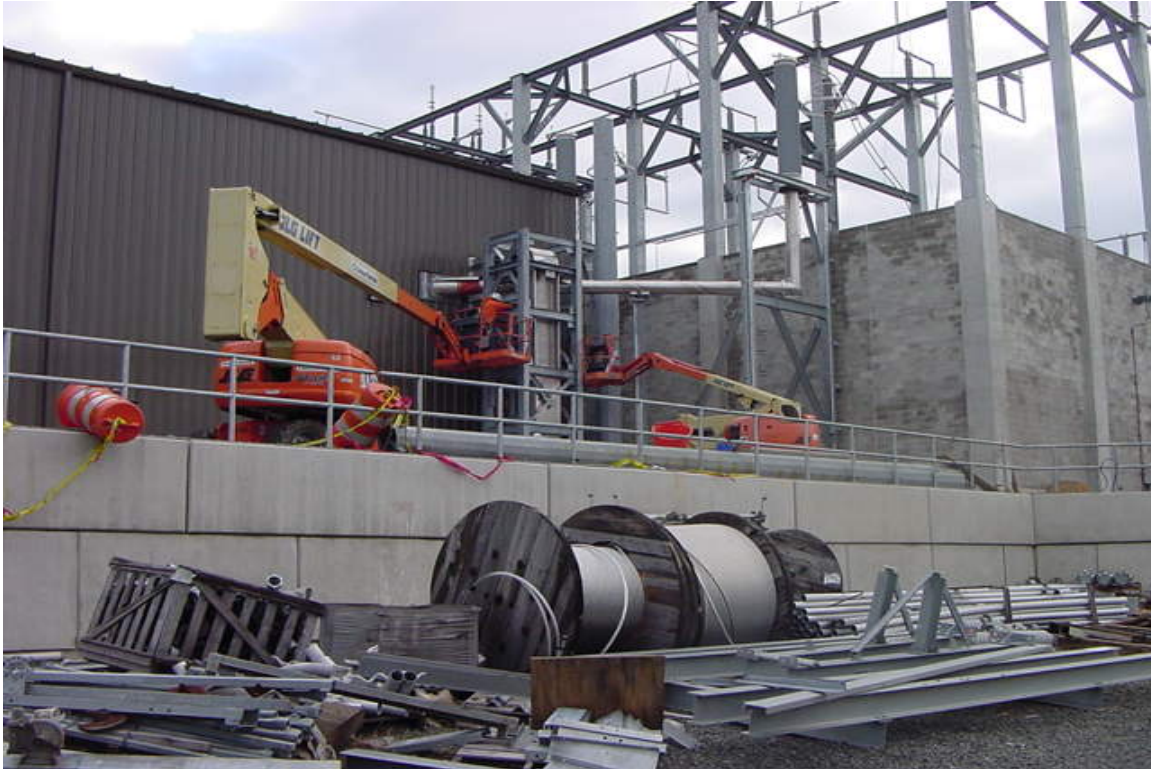
View of the ongoing work adjacent to the GIS building. 12/30/05.

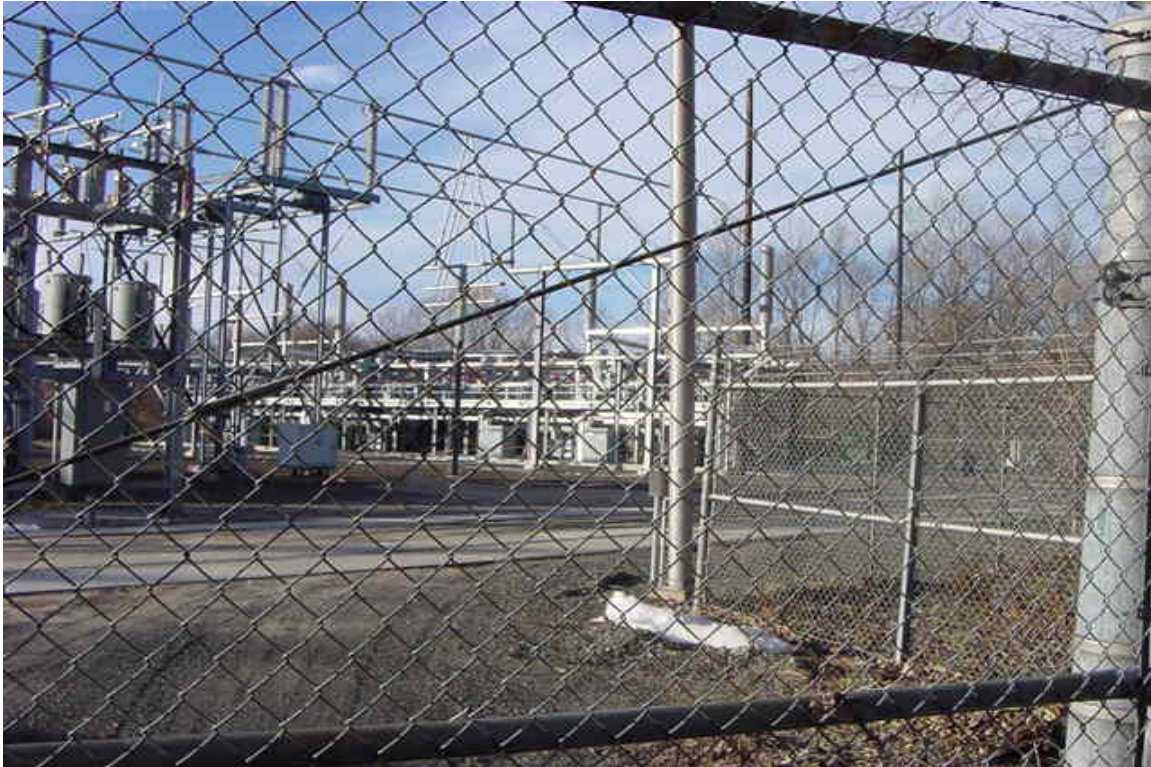
Plumtree Substation: View of the yard where external work has not occurred for some time. 12/30/05.

Additional Observations	- Following completion of a few future scheduled activities, this substation can be removed from the inspection route. 12/30/05.
